David Kelly's report was as follows:

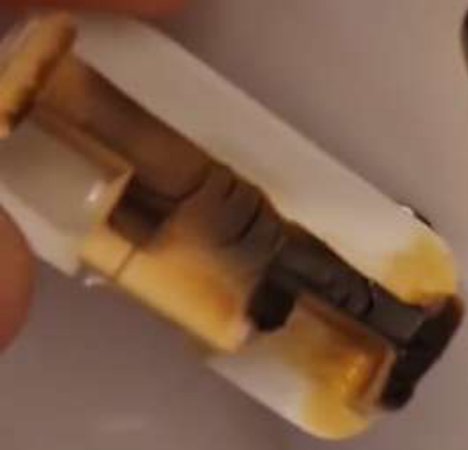
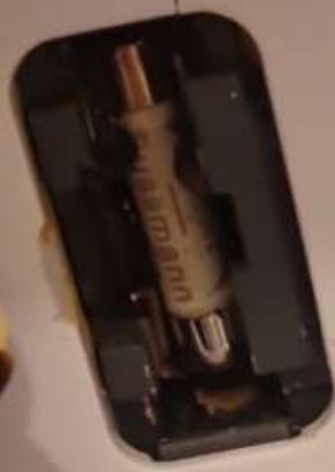
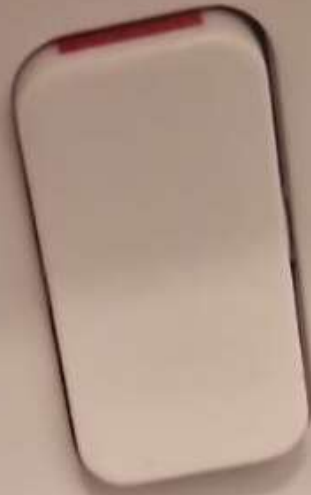
IMMERSION 1

The Horstmann control unit was wired incorrectly since fitting. The unit had two supplies when only fit for one. The Immersion 1 off peak (base heating unit) was connected via a link to the Immersion 2 peak heating unit as shown in the image. This has likely caused a continued overload of Immersion 1.

The electronic display and control unit is designed to run off the supply of one switch with an insitu boost switch to operate the second immersion heater if needed to boost hot water supply. This was not how the product in Apartment 8 was wired.

Wiring corrected and switch tested to 20amp fuse tolerance.
